# STRAIGHT AXLE SAFETY

Noland Adams

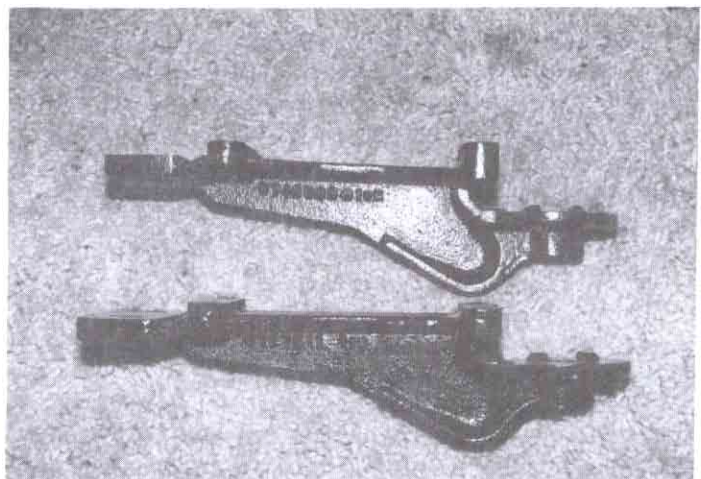
**IDLER ARM BRACKETS:** The rear boss is thicker on later versions.

The thickness of the rear flange of the later bracket is the difference. The two early (1953 to 1957) brackets has a thinner flange (about 5/8"); the later bracket has a thicker rear flange (one inch).

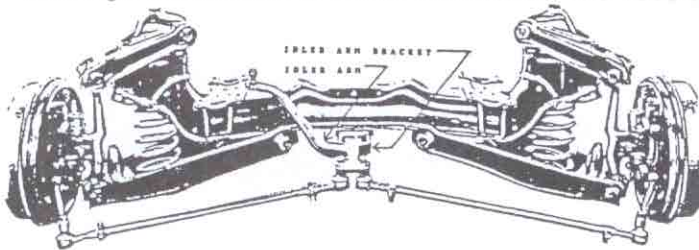
Upon examination, Laurie found that the cast iron part that bolts to the underside of the front crossmember was broken. The tie rods were still connected, flopping around uselessly. It was something that neither one of us had seen, so we thought it was an isolated case.

THE 1953 TO 1962 FRONT END FROM THE REAR, SHOWING THE IDLER ARM AND BRACKET

The bracket mounts to the front crossmember; the idler arm rotates in a large circular bearing located at the rear end of the bracket. Every time the steering wheel is rotated, the front tires are turned back and forth to steer the car. Tremendous pressures are placed on the arm, bearing, and bracket. These stresses can build up and cause the bearing housing portion of the bracket to break. *And I mean break right off, causing complete loss of steering, and the car goes who-knows-where.*

We now know of two complete failures (breaks), and another which showed cracks around the bracket's load-bearing area. We have just begun checking these brackets for cracks, so who knows what we'll find. We must all check this item at once, in order to avoid a complete steering failure. We are all grateful that Laurie Ames wasn't just pulling off the freeway off ramp when his idler arm bracket broke.

When and where will yours fail? Such parts crack before they break. **Inspect yours before you drive it again.**

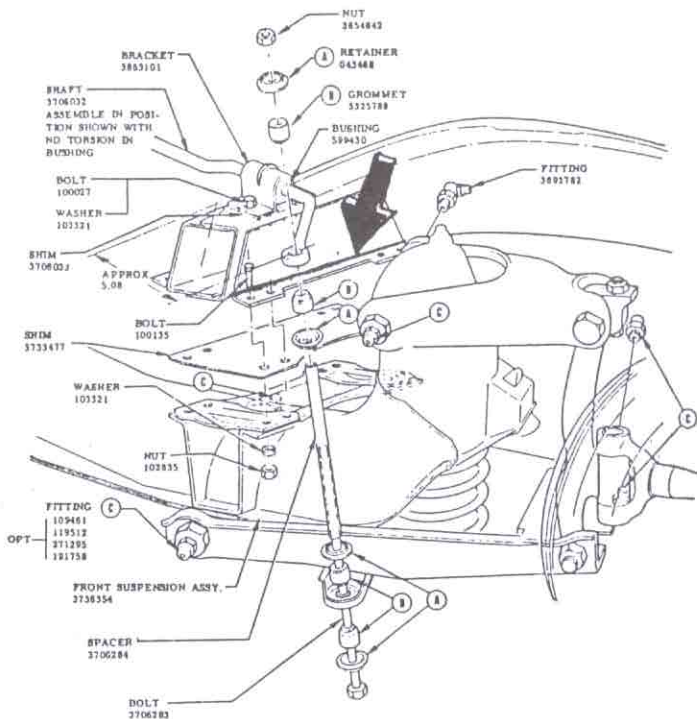
**THE ARROW POINTS TO THE BENT AREA OF THE FRAME BRACKET WHERE CRACKS MAY BE LOCATED.**

These cracks are in the corners of the front frame bracket. This bracket is riveted to the sides of the frame: it is bent 90 degrees, with its lower edges flush to the bottom of the frame. If you have a 1956 to 1962 Corvette, a tapered aluminum shim (one per side) is placed between the front crossmember and this bracket.

The brackets on some cars are cracking lengthwise in the middle of the 90 degree bend. The best cure seems to be the one used by Bill Harm. That is, weld the bracket securely from the backside. The original cracks may still show, but the bracket is firmly attached. Welding from the top side would be successful, but it would show, and it might interfere with installation of the front crossmember mounting bolts.
