1953 - 1962 SECTOR SHAFT BEARING

By Tony Catalano

3719963 GROMMETS

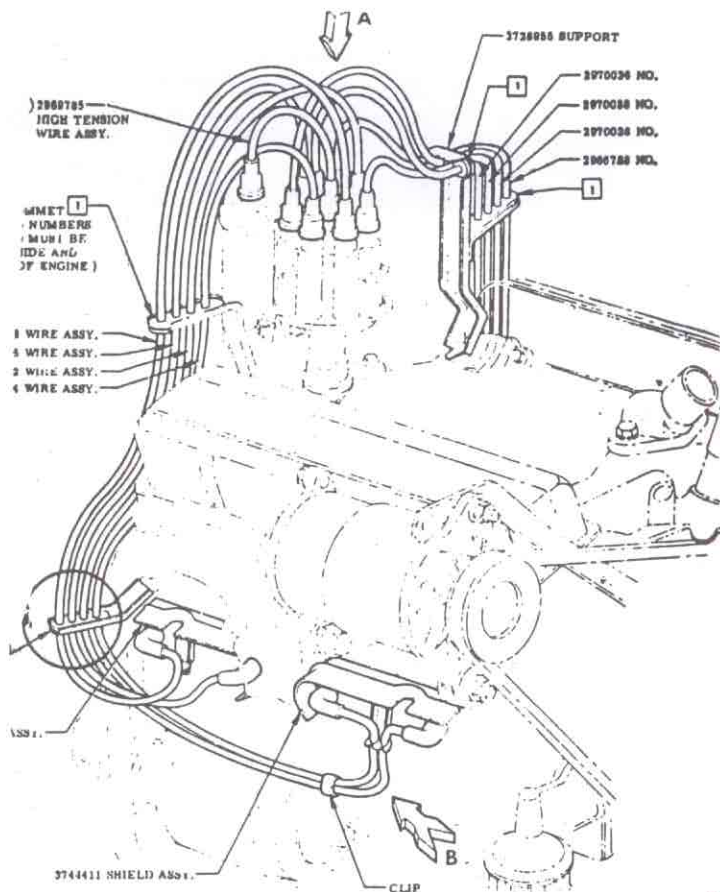
Later, I was installing new plug wires again, thinking I had gotten some bad ones when I noticed the rubber grommets that hold the plug wires were numbered and wondered why GM did that. Then I realized it was the firing order of the cylinders. Well, if GM marked them, then I would follow suit placing each wire in its proper location.

You guessed it, she idled smooth and ran great with no miss. Later I asked an old mechanic about this and he told me that because of the firing order, something about cross fire or bleed through from one wire to the next, the wires needed to be separated (in order). That's the best way I know to explain it to you, but take it from me, it works. If you have this problem, just correct the plug wires and see if that won't correct your problem.

Left side grommets facing up will read odd numbers. Right side grommets facing up will read even numbers.
