Hard Top, Side Window REPLACEMENT

By Tony Catalano

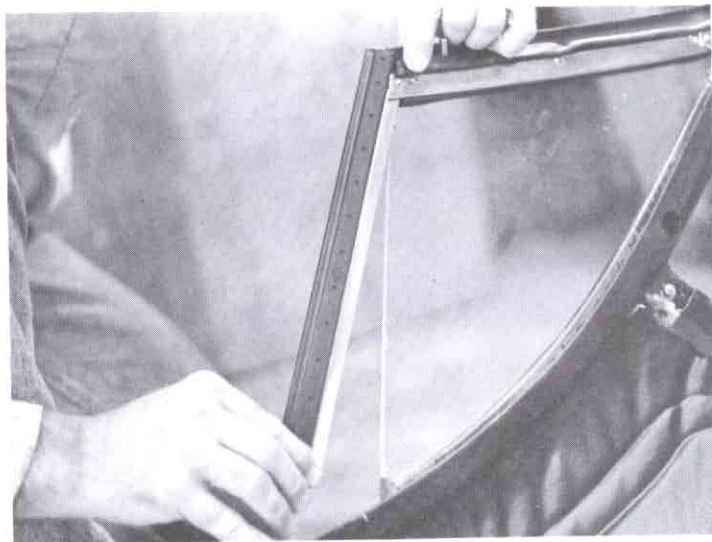
I was able to take a hold of the unriveted top end of this vertical channel and carefully swing it forward in a pivoting manner. At this point the

channel is pivoting out and away from the window on the rivet that we are trying to save. While carefully working at it, I was able to slide the old windows out without damaging the channel from the binding action.
