STRAIGHT TALK

VOLUME 5, NUMBER 4

DECEMBER 1991

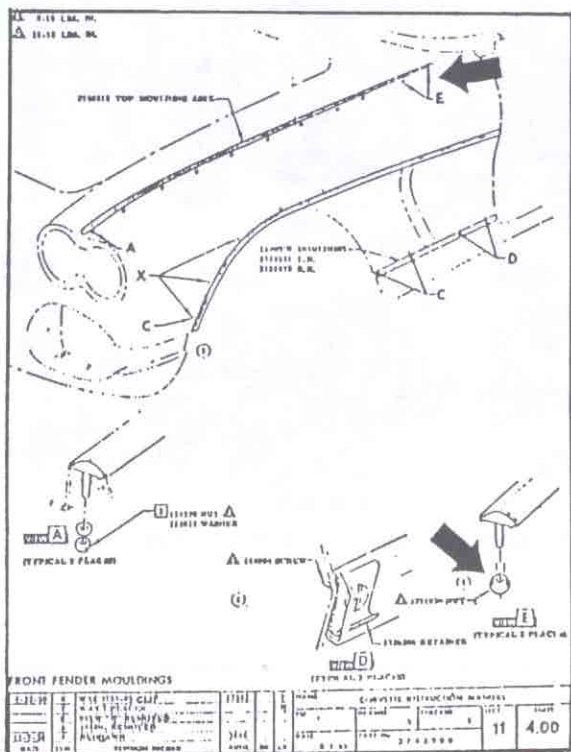
Diagram #1 — Front Fender Molding. Top arrow shows clip locations, bottom arrow shows revised nut.

are different. The first 9 holes are large and elongated. The last two holes are also elongated but are smaller. The idea being that the small metal clip will pop into the small holes from the top of the fender and will remain flush with the top of the fiberglass. They are held in place with a small lip at their top end. The lip is accompanied with two very small spikes, one on each side of the lip. These are too small to see in the photo. They are to dig into the fiberglass in order to help secure them in place. When the stud sticks into the clip it will merely pop into place and will be held by friction. The clips and studs are to be plugged with filler clay to prevent water leaking into the passenger compartment and onto the carpeting. If you're having one of those mystery water problems check this one out, it is a main source. Unfortunately these clips do not seem to be easily found. It's not even easy to find out what they look like or that you need them. I refer to the 1958 and the 1959 parts and service manual. Both of these manuals indicate that the last two attachment studs are to be secured with nuts. Although the diagram calls for nuts at these two locations, the drawing shows a part that is very different from the nut that is called for at the first 9 locations (see diagram #1 bottom arrow). This nut is not only different, but was nut used on 1958 and 1959 cars. At the page bottom of diagram #1, listed under Revision Record you will find part number 3753485, clip date revised 4-22-59 indicating that the clip was discontinued and that the new part was now to be substituted. (This will be difficult to read from this diagram due to its reduced size but you will see it in your assembly manual). This only shows what the changeover is to be, but gives no indication of what the clip was, or that it had even been used.

As stated before, this clip was necessary because there was no access from underneath to attach a nut to the last two studs. Evidently the clip did not hold the spear in place adequately and it was felt the screws were necessary. In order to accommodate this and to facilitate access, the metal bracket that had previously been in the way was modified. (See diagram #2, this identifies the location of the metal bracket in relation to the rest of the car.) The original bracket had been made from aluminum. See photo marked Photo #4 1st Design Aluminum Bracket. It had two very small holes that correspond to the location of the studs. They may have been provided in the event that, if for some reason the bracket were installed too close to the fender or if a stud were too long, there

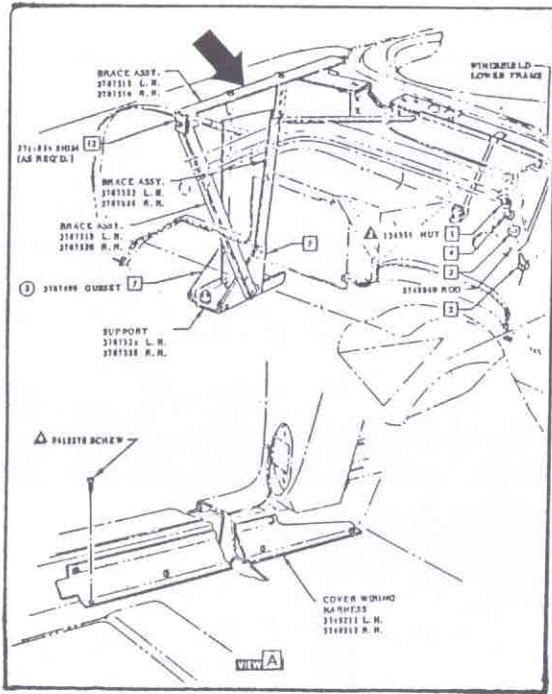
Diagram #2 — Identifying the location of the metal bracket.

Now you're ready to make the installation. Start by placing the nut on top of the metal bracket that

lies between you and your objective. Maneuver it directly under the stud hole in the fiberglass fender, than place the molding spear onto the fender and into the holes. In doing so the stud will pass through the fender and directly into the nut or speed nut. It will be necessary to do it this way because there probably will not be sufficient room to get the nut in place if the molding spear stud is already in its place. The space where this nut goes, that is, between the metal bracket and the fiberglass fender, will probably vary from car to car depending on how the car was assembled. Some may have even less room.

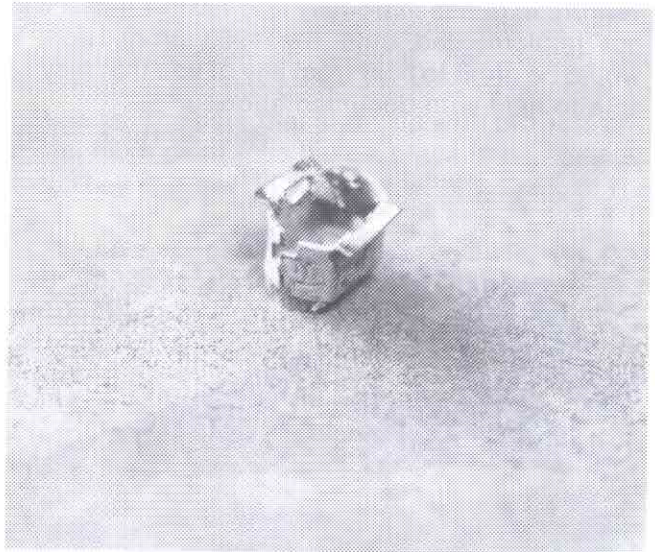
Photo #3 — This is the special clip retainer that holds the last 2 studs of the top fender molding.

marked by upper arrow showing place E) are held in place by way of a clip (see photo #3 marked, molding clip). The clips are necessary because the last two studs enter the cockpit side of the fire wall and end in an area that is not accessible for the attachment of nuts due to the location of a metal bracket. The other 9 places come through the fender and are easily reached by way of the inner wheel well. Even the stud holes in the fender

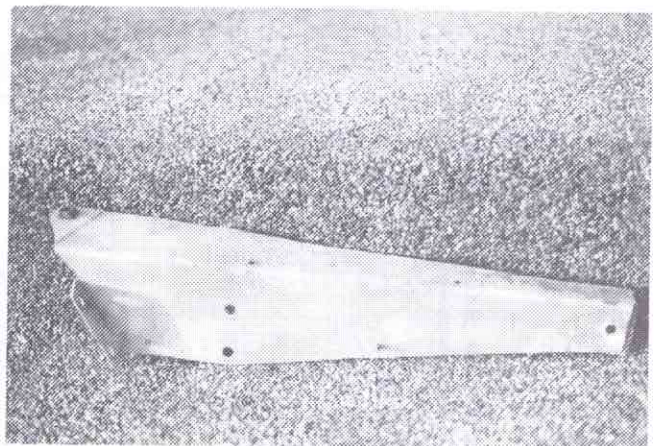
Photo #4 — 1st design aluminum bracket. This is a right side bracket.

Again I will point out that the clips for the fender molding were used on 1958 and 1959 cars until the aluminum brackets were changed to steel brackets with the large access holes. As stated before, the changeover date on the worksheet was to be April 22, 1959. When the actual change occurred, I don't know but would venture to guess extremely late 1959 or that it was not implemented until the 1960 production. It would be great to hear from any of you that may be able to help with documentation.

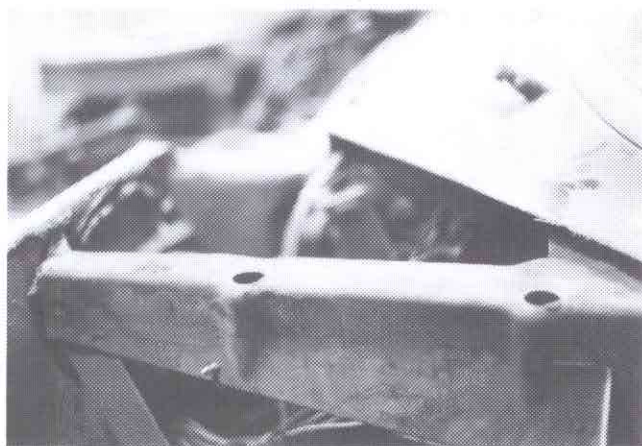
Photo #5 — 2nd design steel bracket with large nut access holes. This is a left side bracket.

would be a margin for error and the studs would have some place to go. As for the new and improved modified bracket, see photo marked Photo #5 2nd Design Steel Bracket, it was made of steel and was provided two nice large holes so that a tool could be used to accommodate the insertion of a nut that would more permanently secure the studs.

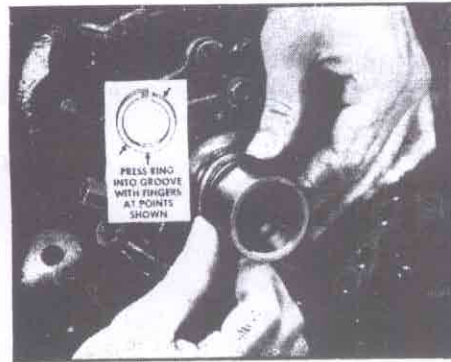
Fig. 40 Installing oil seal rings. 1953-1961

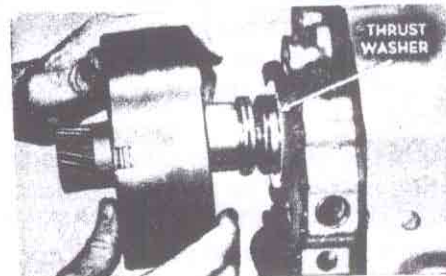
Fig. 41—Step A. Install low drum to valve body thrust washer and clutch assembly on oil delivery sleeve

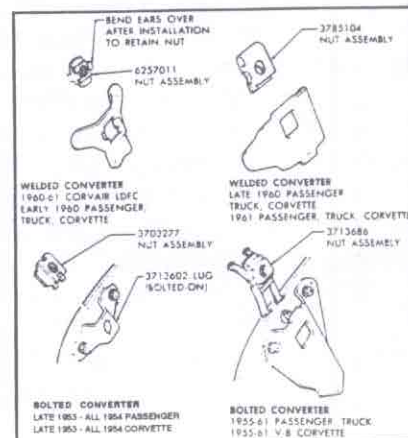
POWER GLIDE CONVERTER DRIVE LUGS

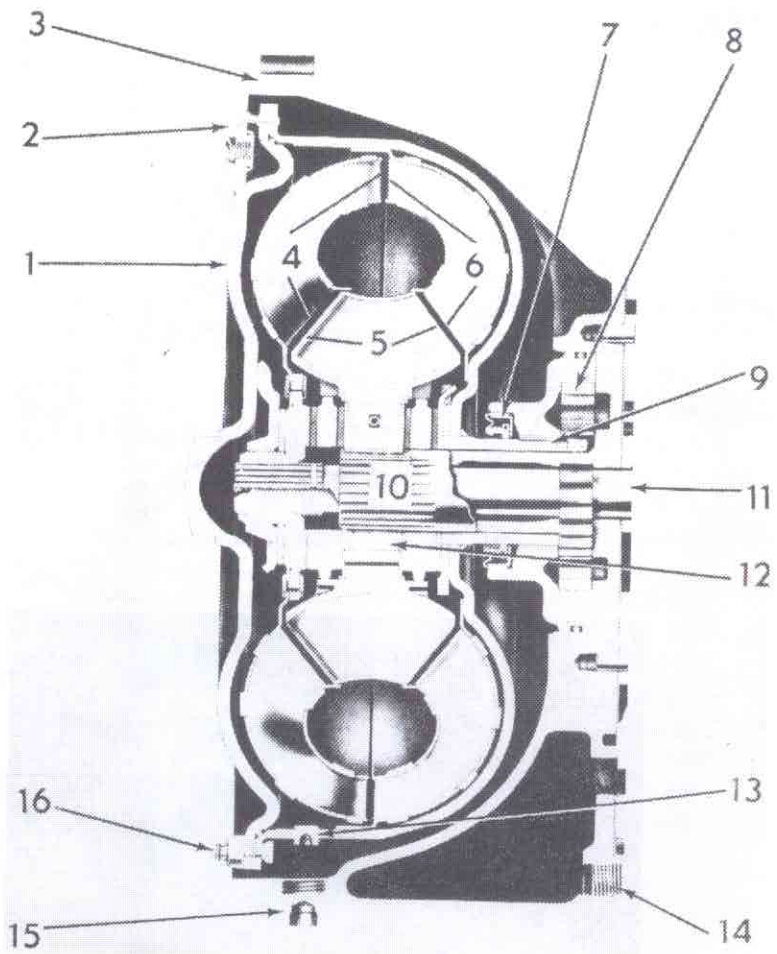
Fig. 18—Cross sectional view—torque converter—starting with 1953 production

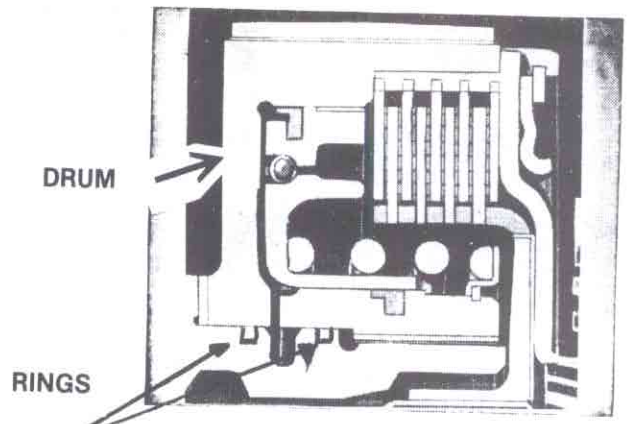
Fig. 129 — Cutaway view of clutch drum showing rings.

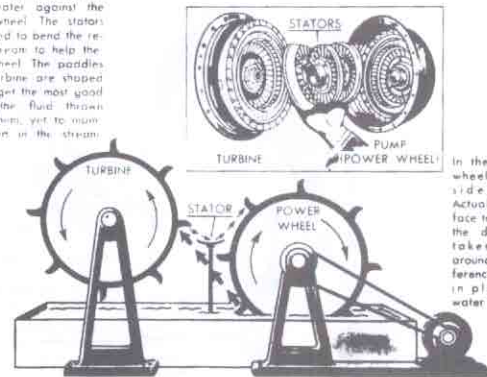
In the model, the wheels are shown side by side. Actually they are face to face so that the driving action takes place all around the circumference. Oil is used in place of the water in the model.

Fig. 12—Operational theory of a torque converter.

When the turbine is stationary the fluid passes through it and the stators and so back to the pump with almost as much energy as when it started. This energy is added to the energy being given the fluid by the primary pump and provides the high initial torque necessary to start the car moving.

The power wheel throws water against the turbine wheel. The stators are shaped to bend the returning stream to help the power wheel. The paddles on the turbine are shaped so as to get the most good out of the fluid thrown against them, yet to maintain speed in the stream.

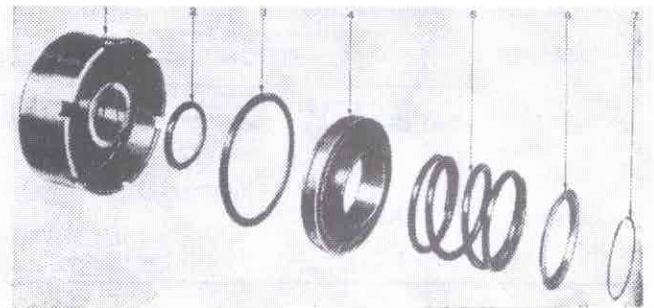
Fig. 39—Exploded view of low drum assembly all models

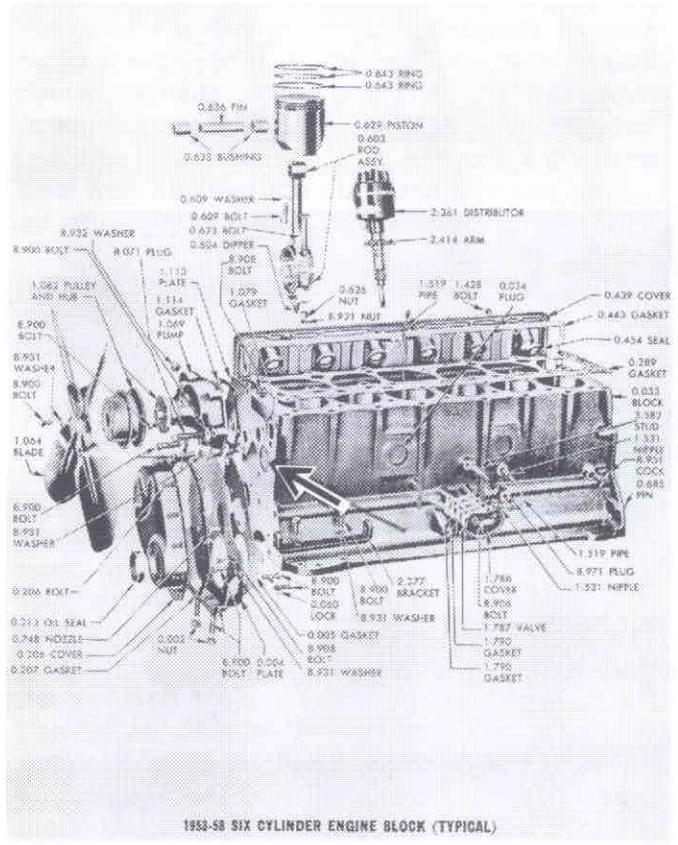
1953-58 SIX CYLINDER ENGINE BLOCK (TYPICAL)

rebuilders are thinking CAR not Corvette. Car would use the large freeze plug because the water pump arrangement is different. But Corvette lowered the pump to clear the upper radiator hose, which in turn changed the arrangement, this caused the large freeze plug to be removed on Corvette only. If you have this problem or are having your engine rebuilt, remember to have it removed. You will see by the pictures of the block and pump spacer why this is important.

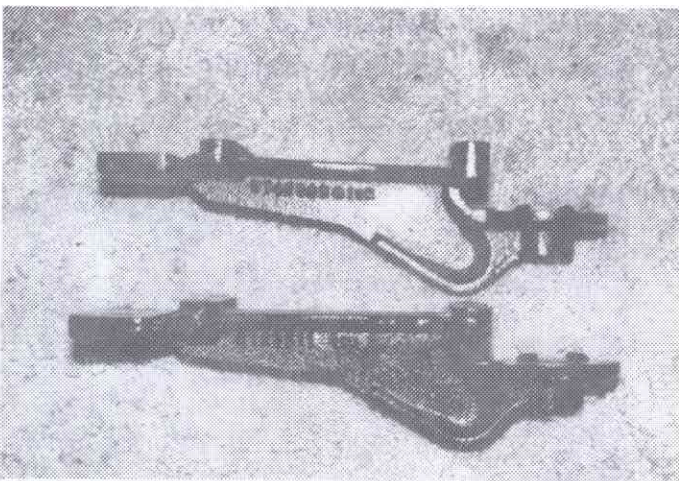
IDLER ARM BRACKETS: The rear boss is thicker on later versions.

First, we should identify this part. It's proper name is "Bracket, steering idler third arm." There were three different brackets used on 1953 to 1962 Corvettes. Part number 3706024 was used from 1953 to 1955; this number is forged on the side in depressed characters.

The 1956 and 1957 bracket was 3727511; this number was forged on the side in raised characters. The 1958 to

1962 bracket was part number 3742688; this number is also forged on the side in raised characters. Part number 3742688 is also available as a reproduction, which may be identified by the forged number 3742688 or 3742888 and the letters "TMS."

Since the rear flange of the later part is thicker, that would change the whole angle of the tie rods and steering idler arm. It appears that the brackets and arms are matched,

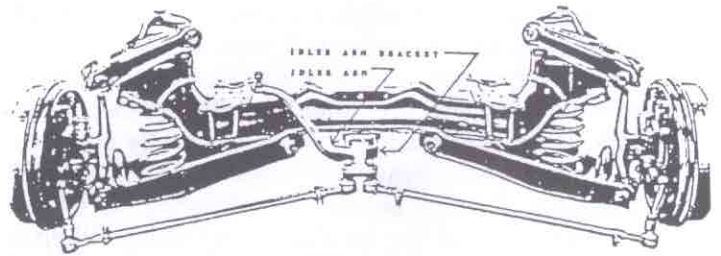
THE 1953 TO 1962 FRONT END FROM THE REAR, SHOWING THE IDLER ARM AND BRACKET

So much for part and forging numbers. Let's identify the part further. It mounts under the front crossmember directly under the center of the radiator. If the steering is equipped with a quick steering adapter, the adapter is an extension that bolts onto the idler arm; the tie rod ends are relocated to holes in the extension.

The bracket mounts to the front crossmember; the idler arm rotates in a large circular bearing located at the rear end of the bracket. Every time the steering wheel is rotated, the front tires are turned back and forth to steer the car. Tremendous pressures are placed on the arm, bearing, and bracket. These stresses can build up and cause the bearing housing portion of the bracket to break. *And I mean break right off, causing complete loss of steering, and the car goes who-knows-where.*

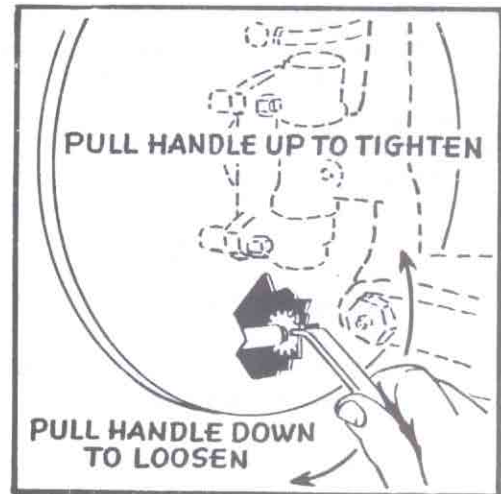
Fig. 8—Bendix Brakes—Move the handle of tool towards axle to expand the shoes and away from axle to retract them

Jack up the car and remove one wheel and drum assembly and examine the condition of the lining and drums. If all is okay replace the wheel and drum assembly. Remove the cover from the adjusting slot hole at the lower end of backing plate and, using a special brake spoon or bent screwdriver, pry the star wheel adjuster (handle of the tool in the direction of the axle) to expand the shoes until the shoes are tight against the drum, **see Fig. 8.** At this point it might help a little if the anchor nut at the top of the anchor plate is tapped lightly with a hammer to assist the friction-held anchor block to center itself properly.

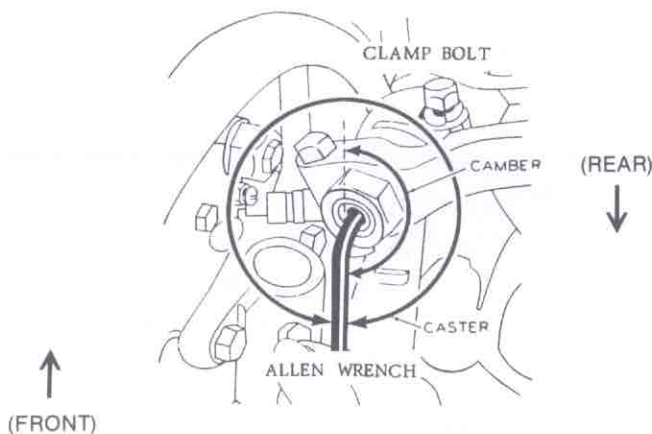
Fig. 27—Caster and camber are adjusted at the same pin. Maximum camber can be obtained in not more than 1/2 turn from the correct caster setting—Chevrolet shown

Remove the grease fitting from the front bushing and, working through the grease fitting with an Allen wrench, engage the eccentric pin at the front. Loosen the clamp bolt in the top of the knuckle support which will leave the eccentric pin free to turn.

Now turn the eccentric pin (which has a right hand thread) first in the direction which tends to correct caster, that is, the pin would be turned counterclockwise to increase caster or clockwise to decrease caster. If it is necessary to decrease caster, turn the pin clockwise until the correct caster setting is attained and then rock it back and forth until the correct camber reading is obtained. Since both adjustments are made at the same pin it is sometimes absolutely impossible to get exact readings. However, it will be found that with very little error in caster, the correct camber reading can be obtained.

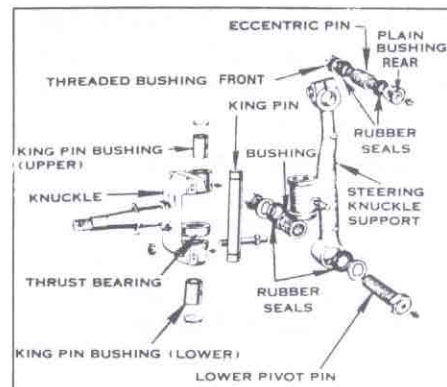
Fig. 9—Upper and Lower Pin and Bushing, shown exploded with the king pin—

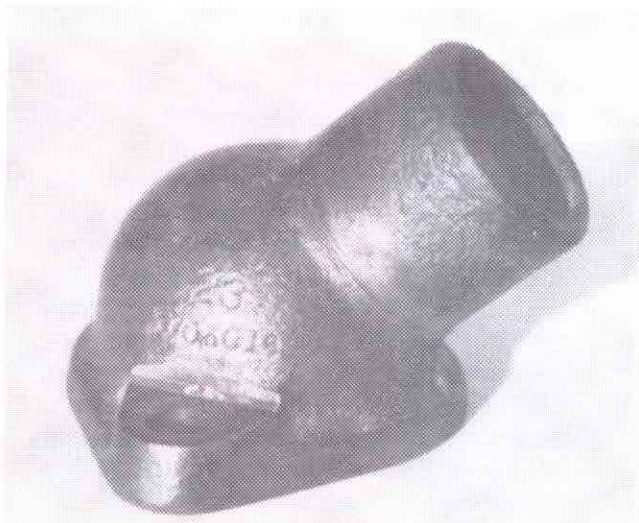
First design EARLY 1956.

Many owners have asked about the early Thermostats on aluminum intakes. EARLY 1956 first design on maybe the first 400 or 600 Vettes used the cast iron. Then later GM realized that not having a lip on the neck, the hose would tend to come off, also there was the problem of electrolysis (iron on aluminum). Then the second design came on in 1956 to 1962 and early 1963 which was a aluminum housing having a lip. The part number was casted into the right or left side with some having small numbers or large numbers #3837223. Again GM realized that the neck was weak when removing the hose and again made a change by thickening the area under the neck and that was the third design. There was also a fourth, and fifth design in later mid-years. I printed some incorrect information in Volume 1 Number 2 about this and I hope this will clear up any confusion.

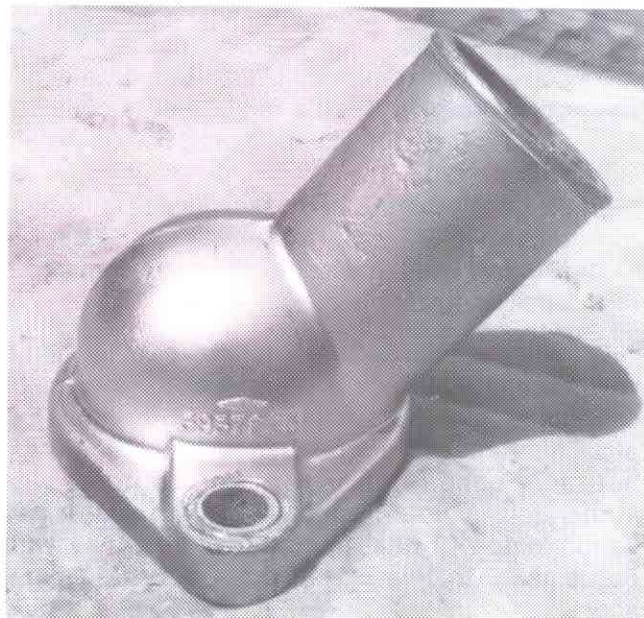
Second design 1956-1963.
