# Blue Flame Special

VOLUME 2 NO. 2  
APRIL 1970

# Vintage Corvette Club of America

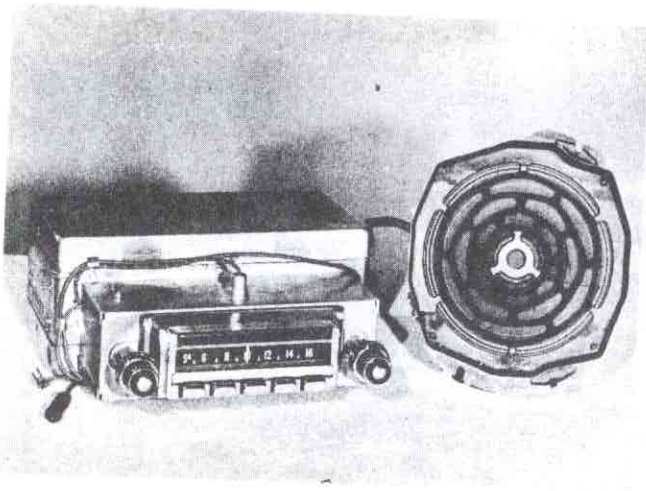
Figure 1

This radio is a nine tube (with rectifier and trigger) superheterodyne automobile receiver designed expressly for the Chevrolet "Corvette". The radio consists of a radio receiver unit, with an external speaker and power supply unit. This type of design is advantageous for both installation and service, as all component parts of the receiver are readily accessible for quick efficient replacement when service is required. Using an external type speaker affords the advantage of having a large speaker in a limited space area. The speaker is coupled to the instrument panel by a special type gasket, thereby using the entire instrument panel for unusually good tone reproduction.

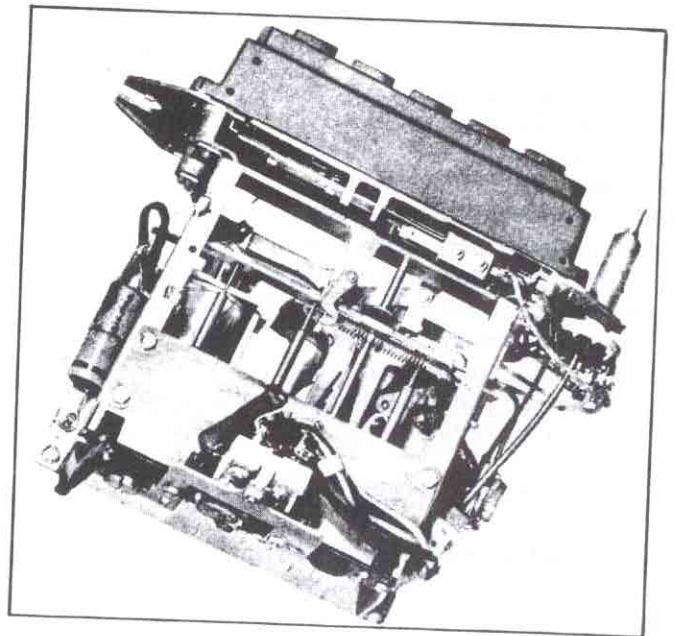
Figure 2

The circuit used in this receiver is the superheterodyne type that uses no regeneration. The tuning circuits are of the permeability type and are tuned by varying iron cores in and out of the antenna, radio frequency and oscillator coils like

pistons. See Figure 2.

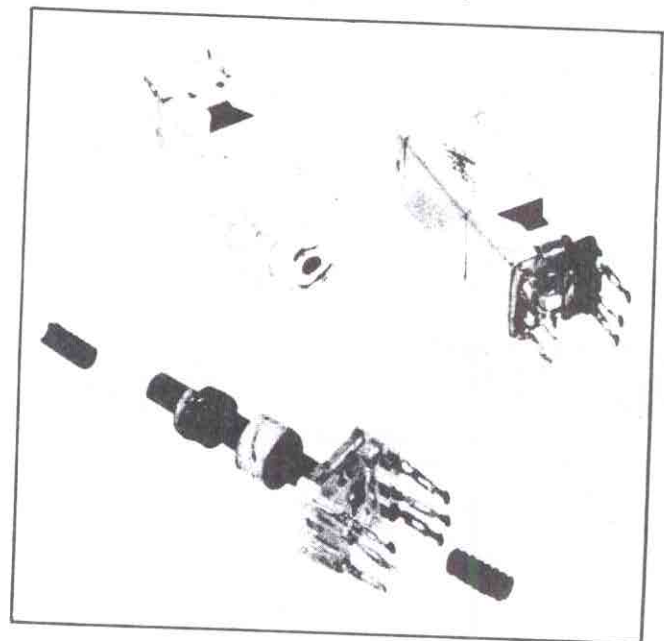
Figure 3

The Intermediate frequency stages are tuned by means of two iron cores in each transformer and are adjusted with an insulated screwdriver from the top and bottom of the transformer. Both the first (input) and second I.F. (output) transformers are tuned by this method. See Figure 3.

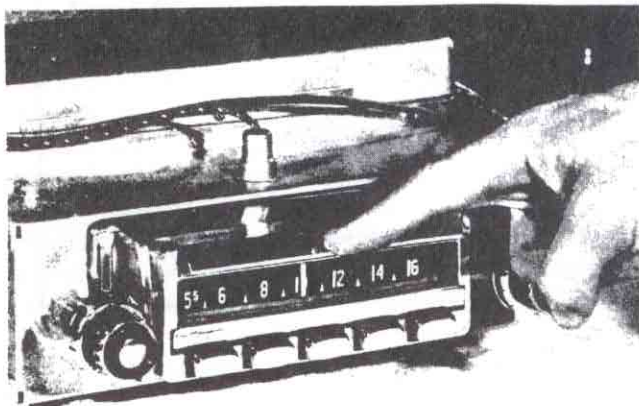
Figure 4

An outstanding feature of the Corvette radio is the new Signal Seeker tuner. In addition to manual tuning, the radio can be tuned automatically using the station selector bar in conjunction with the sensitivity control to obtain all available stations or only the stronger stations. The tuner also includes five push buttons which can be pre-set to automatically select favorite stations.

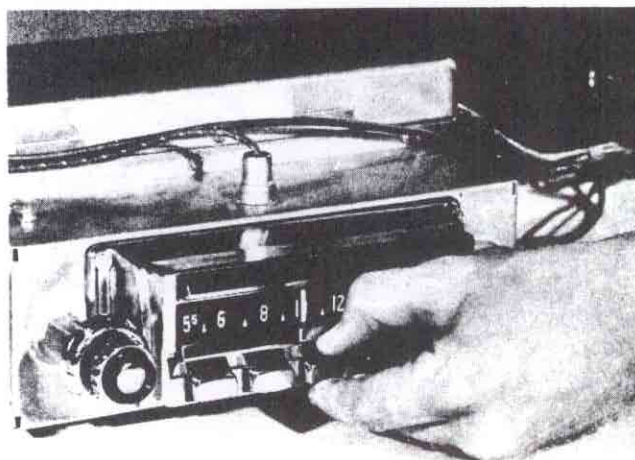
Figure 5

1. Open the hinged door below the dial exposing the selector tabs.

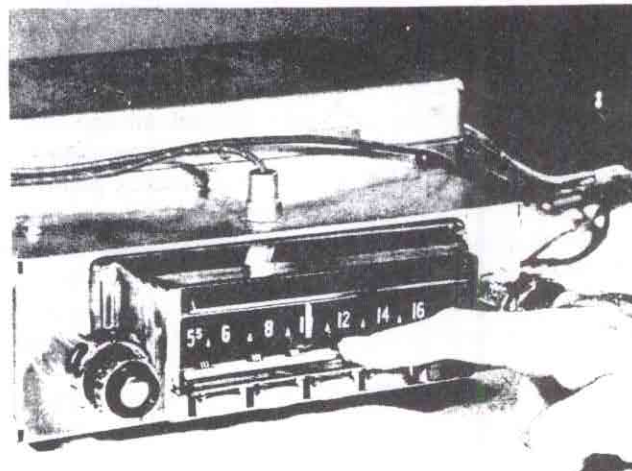
Figure 6

2. Tune in the desired station nearest the left end of the dial.
3. Move the first selector tab (one farthest left) until it lines up with the pointer tip.
4. Repeat set-up steps 2 and 3 for the remaining selector tabs, choosing stations from left to right on the dial.
5. Check the setting of each selector tab by depressing the corresponding station selector button. If the correct station is not tuned in, readjust the selector tab; either slightly to the right of the dial pointer or slightly to the left of the dial pointer until the desired station is obtained by the selector button.

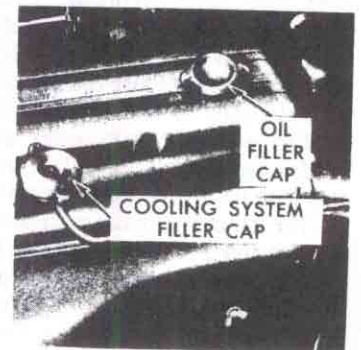
Fig. 28—Engine Oil and Cooling System Filler Caps

Next, let's look under the hood of the 1954. One of the first things we can see is the valve cover as pictured in Fig. 28. The valve cover is square in configuration with rounded off edges and ends held in place by four small flat head screws.

In contrast to 1953 which were extremely rounded off both front and rear and held in place with two bolt studs. One other difference in the valve covers is the oil filler cap. In 1953, the filler cap's position was about two thirds towards rear of the cover, whereas the 1954's filler cap is positioned on the extreme forward part of the cover. To my limited knowledge the valve covers, top and bottom, shielding came in the Chevrolet blue-green color, but I have seen many chrome ones either just the valve cover or all three pieces

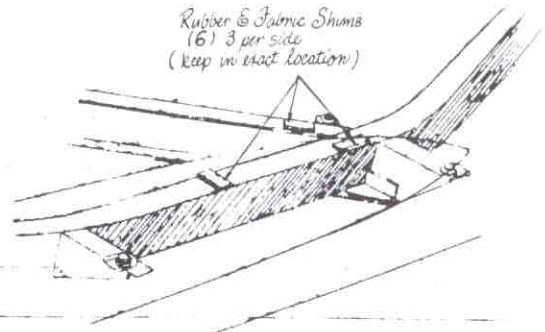
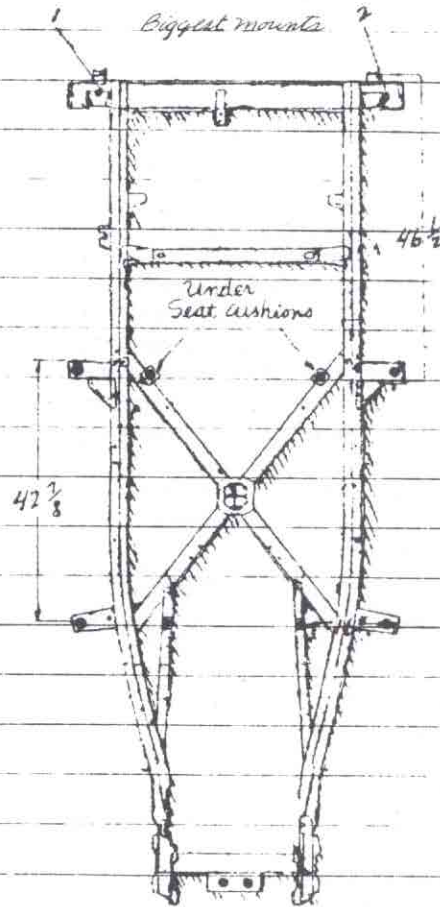
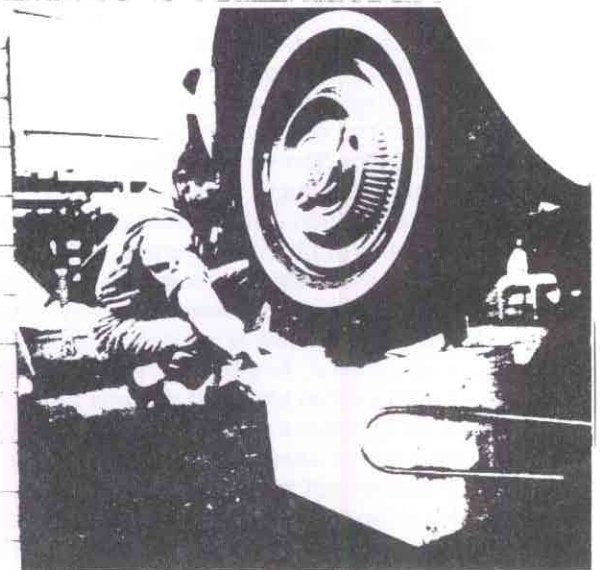
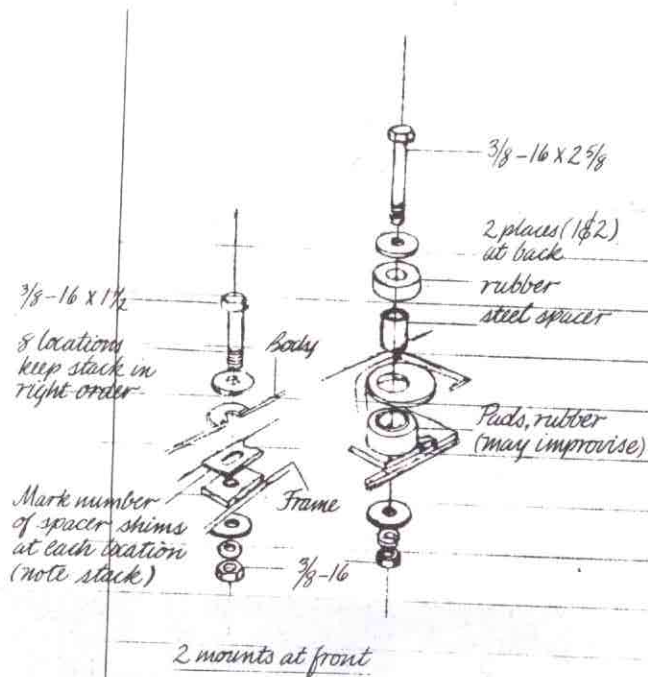
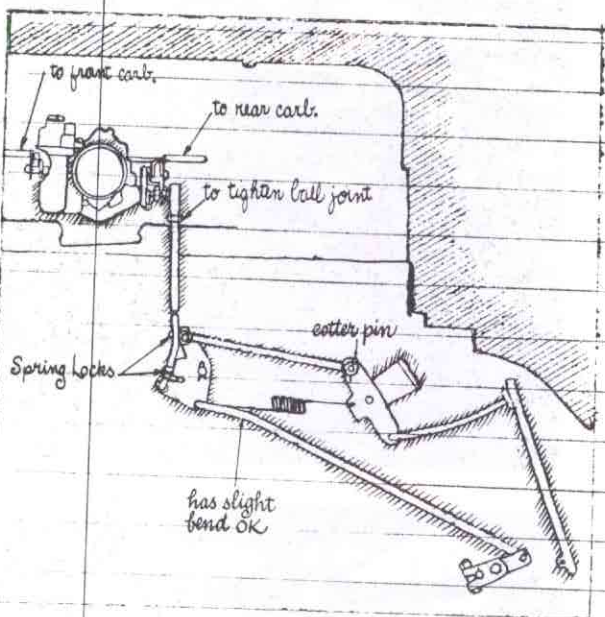
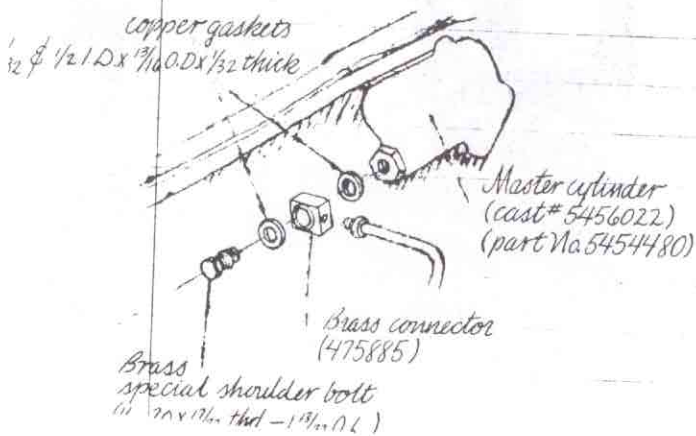
At this point (6-8 man-hours) the body was ready to be lifted from the chassis. It was decided to attach hooks in the trunk on the rear bumper brackets. At the front, hooks were placed in hood-latch holes. (See photo.) Chainfalls were attached, front and rear. (It is possible to lift the body with six men if necessary.) Caution was required to feed hoses, gas and brake lines through the openings while the body was being raised. After the body was raised from the chassis it was placed on a four-wheel buggy with under braces at the approximate center of the front and rear wheels and a support in the center of the body to keep it from sagging (see photo). Frame-to-body rubber mounts and alignment shims and their order of disassembly were marked for future reassembly. (If not kept in their original order, doors, hood or deck lid might not fit properly.)

Rubber & Fabric Shims  
(6) 3 per side  
(Keep in exact location)

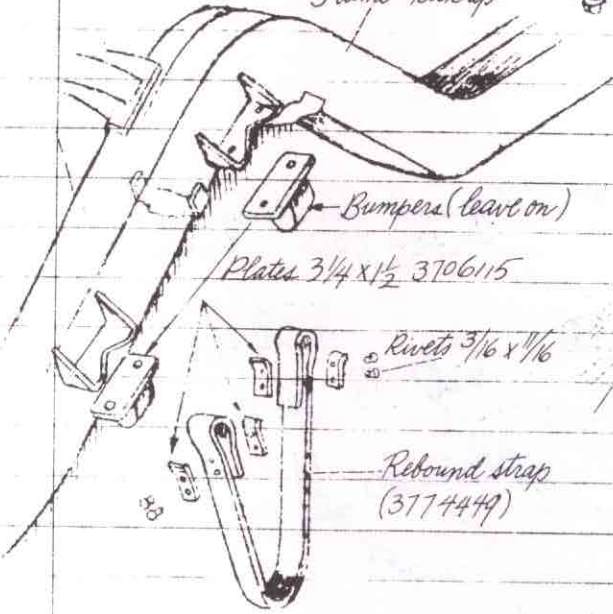
Bumpers (leave on)

Plates 3/4 x 1 1/2 3706115

Rebound strap  
(3774449)

Locks between hose & bracket

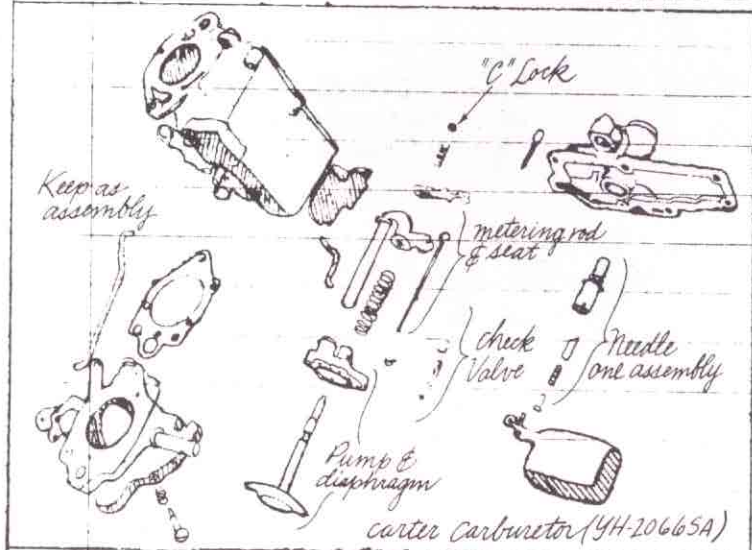
Keep as  
assembly

"C" Lock

Pump &  
diaphragm

Carter Carburetor (YH-20665A)
