# STRAIGHT AXLE SAFETY

Noland Adams

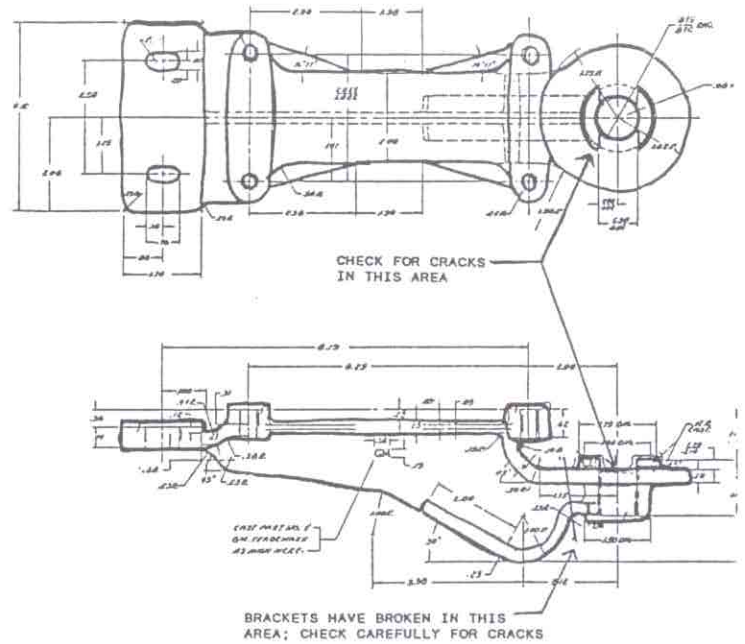
In 1958, the part number remained the same, 3733215, but the arm's forging number changed to 3731801. This 3722125/3731801 armed continued to be used to the end of 1962 production.

Since the rear flange of the later part is thicker, that would change the whole angle of the tie rods and steering idler arm. It appears that the brackets and arms are matched,

and early parts cannot be mixed with later parts and still function properly.

The bracket mounts to the front crossmember; the idler arm rotates in a large circular bearing located at the rear end of the bracket. Every time the steering wheel is rotated, the front tires are turned back and forth to steer the car. Tremendous pressures are placed on the arm, bearing, and bracket. These stresses can build up and cause the bearing housing portion of the bracket to break. *And I mean break right off, causing complete loss of steering, and the car goes who-knows-where.*

We now know of two complete failures (breaks), and another which showed cracks around the bracket's load-bearing area. We have just begun checking these brackets for cracks, so who knows what we'll find. We must all check this item at once, in order to avoid a complete steering failure. We are all grateful that Laurie Ames wasn't just pulling off the freeway off ramp when his idler arm bracket broke.

When and where will yours fail? Such parts crack before they break. **Inspect yours before you drive it again.**
