## EDITOR'S CHAIR

## STATIC - STATIC (53-55)

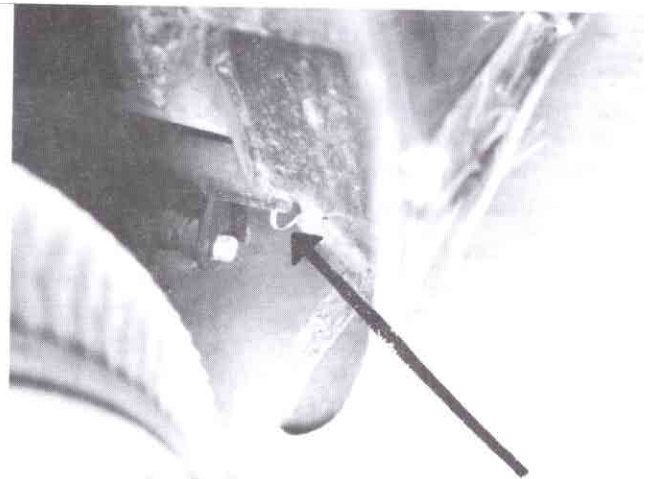
STATIC, always static. I checked and cleaned all the grounding points and still static. When I was about to go bonkers and thinking of replacing the original radio with an aftermarket one, I thought I would try one more time to clean all the ground points. While under the car I noticed a ground wire coming from inside the body on the right side in front of the right rear tire. What was this, I thought. It was corroded and dirty but what was it. I disconnected it from the bolt and cleaned it and as I pulled on it, I realized, it came from the radio antenna. While inspecting both ends, I realized that the cable was wrapped in a ground cable, because at the trunk there was no grounding point. Like a 56-62, it had to be shielded in a wrapping and was then grounded at the radio and frame.

Antenna ground wire

So 53-55 owners, go check that grounding point and see if that solves your static problem. Let me know, Roy Braatz.

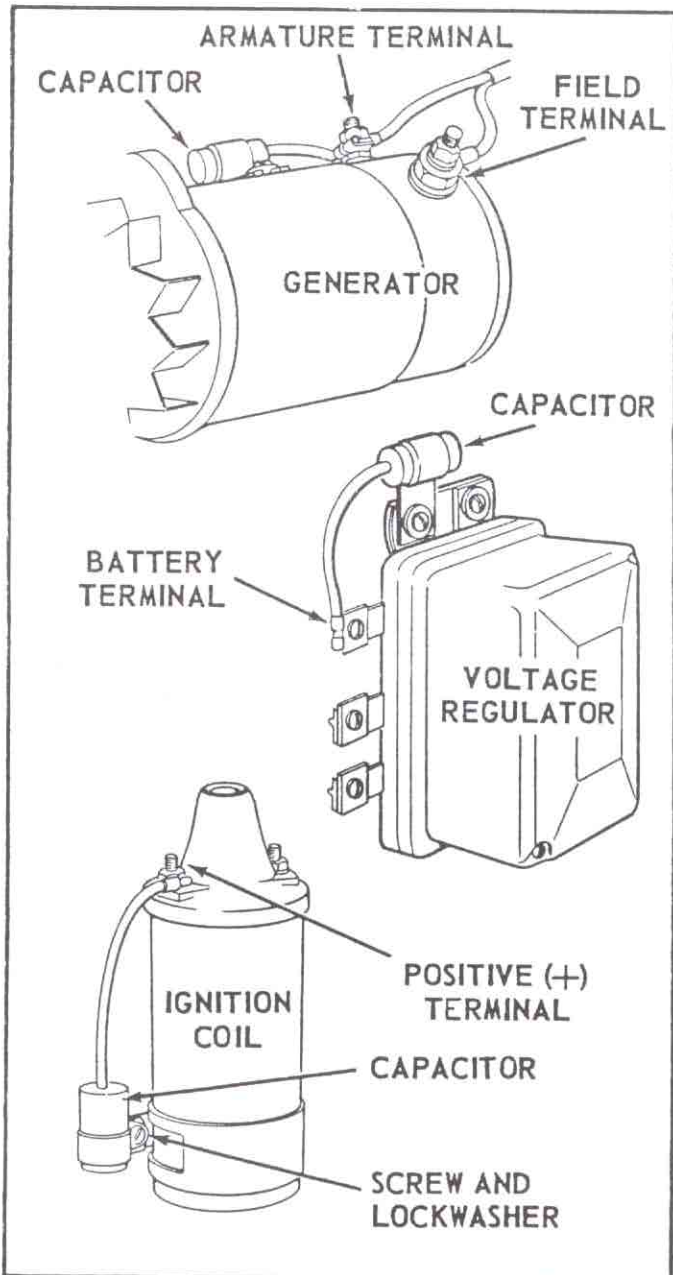
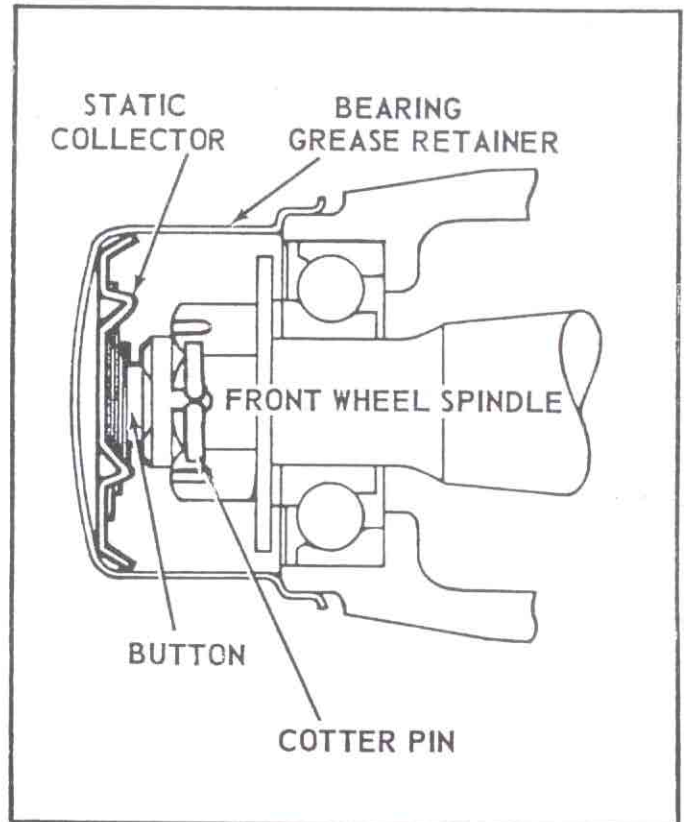
1. Attach the lead wire of capacitor #1911095 (.3 MF) to the armature terminal of the generator (not the field terminal) and the capacitor to the generator housing.

2. Attach the lead wire of capacitor #1917580 (.5 MF) to the battery terminal of the voltage regulator, and the capacitor under the regulator mounting screw.

3. Attach the lead wire of capacitor #1929070 (.3 MF) to the positive (+) terminal of the ignition coil, and the capacitor to the coil mounting bracket with the screw and lockwasher provided.

4. Remove both front wheel hub caps and bearing grease retainers. Clean the grease from the inside of the grease retainers, and from the lathe center hole in each front wheel spindle, to assure good contact. Bend the spindle nut cotter pins around the nuts to insure necessary clearance for the static collector. Put the static collectors in the grease retainers, with the button side out, and re-install the grease retainers and hub caps.
