GRILL TOOTH & GRILL SHELL BACKPLATE

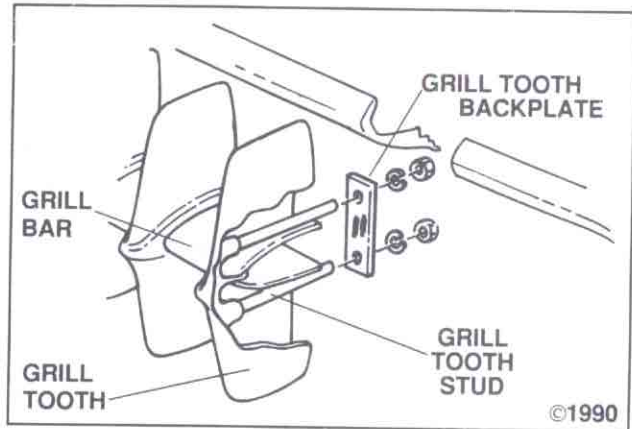
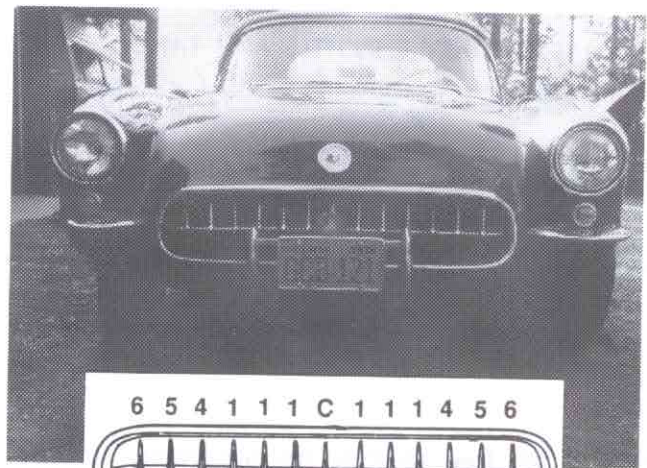
1953-1957 Grill (13 teeth)

3706904

I would like to discuss grill fit! First I will consider that the body has not been damaged, and that the front area where the grill fits is O.K. #1. The backplate that holds the tooth on to the center bar has a mark or logo stamped into it having two lines, see drawing. These were original first design parts used on assembly #2. The four brackets or bars that hold the grill bar and teeth were black enamel and were slotted at each end so that you could expand the shell to help fit it on the body #3. Once you install the grill assembly, the backplates that hold it to the body were also stamped with the same logo as the tooth plates, #4 but the most common area that is lacking is the round area at each end of the grill where fit is usually poor. The drawing showing part #3706904 is what is usually missing if the grill has been taken out in the past and lost. It also will have a logo the same as the others. Owners may not know that this part is missing or haven't seen one before, they may try to install something different to bring the body to the grill and that is O.K., but if you haven't or are in need of the right part, then use the drawing to make one and install one. As far as logos go, this may not concern you, but I thought I would just let you know of this. Also, the repro tooth studs are about an inch too long from the original length, but if you simply cut them to where they protrude about 1/4 inch they will look not so obvious to others.
