## IDLER ARM BRACKETS

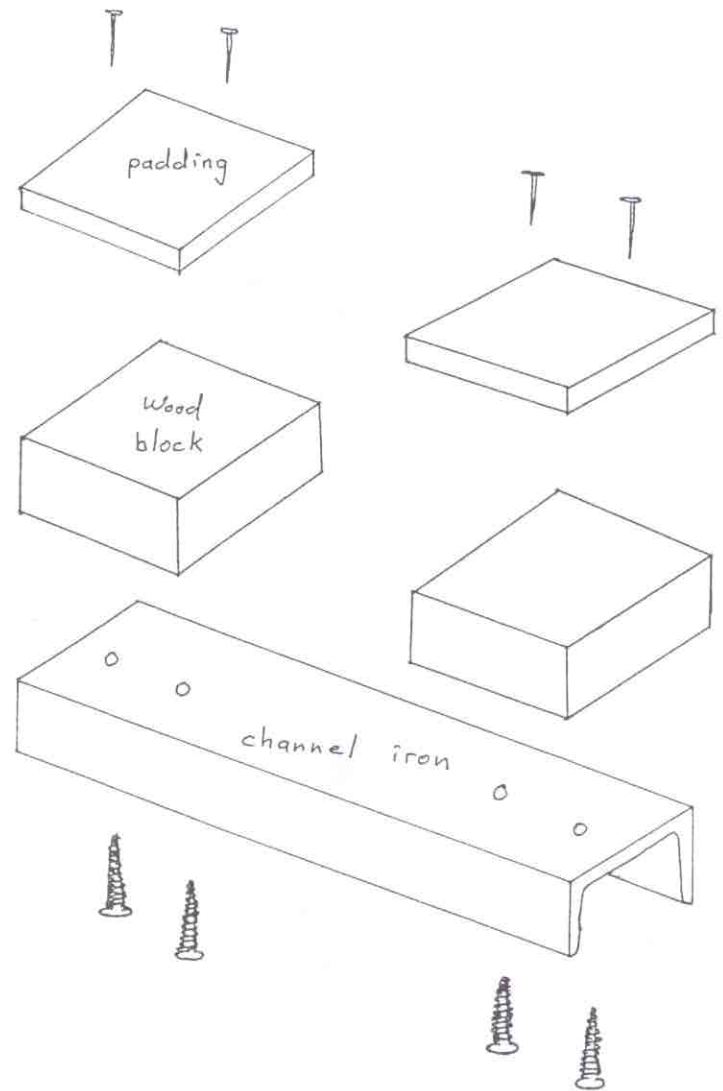
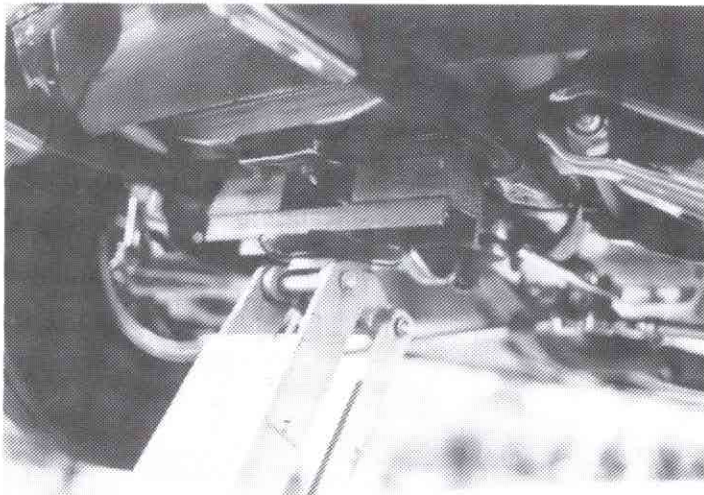
Since that day, I have never jacked my car at the third arm bracket. I have included a drawing of the adaptor that I made to place on my jack that straddles the bracket on my '56 Corvette and my '51 Chevy. I made it from scrap I had around the garage. I cut off a 1 foot length of channel iron (use any size that works for you), 2 wood blocks (made from scrap 2 x 4, or whatever) attached to the channel iron with screws (or nails). I had a large piece of 1 inch thick felt so I cut 2 pieces and nailed them to the wood blocks for padding (you can use a piece of carpet or whatever works for you, or nothing).

The important thing is that it is very easy to fabricate SOMETHING to straddle that bracket if you use a jack under your front cross member.
