# TOP-TANK ALUMINUM RADIATORS

BY SKIP SHARPE

# CRANKCASE VENT TUBES

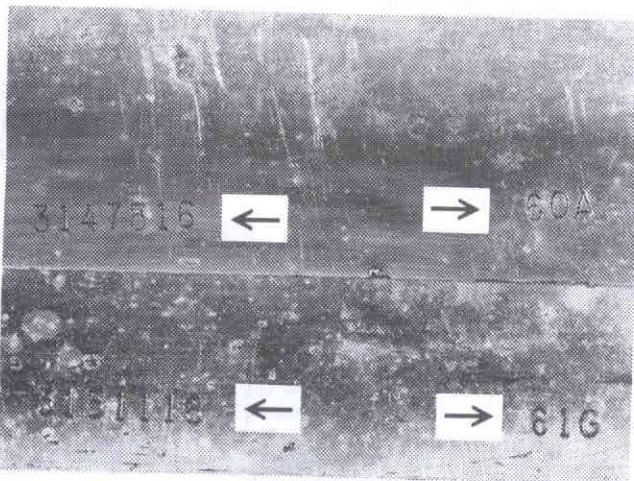
The picture shows two original tags, one on top of the other. The tag on top is from an early "No Hole" top tank that I have had for 20+ years. The bottom tag is from a top-tank "Leaker" I purchased from Alan. Any comments?

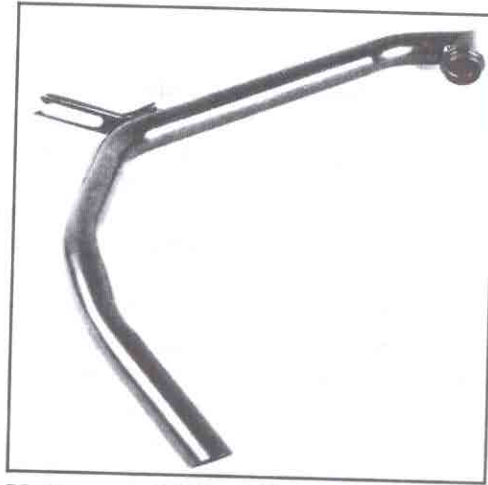
## CRANKCASE VENT TUBE

Many vent tubes on early Corvettes have been replaced or lost over the years and owners that replace it may buy or use the wrong repro. 1953-1954 original has a large X at the top area where car uses a small X. 1955 cannot be mistaken because it ran through the block at the rear. 1956-1958 Vette or 1956-1958 car vent tube was rounded at the top area where a bolt held it in to the block. Also the pipe was welded on its side leading down under the engine. Fig. 2 late 1958-1962 was a second design where the pipe was welded at a 45% angle at the top area. Fig. 1 This is the repro most Vettes have installed because no one reproduces the first design that I know of. 1956-1962 has the factory logo located near the spark plug support bracket on the pipe. Also the clamp that supports the tube at the bottom to the bell housing has the same logo mark.
