KINGPIN BUSHINGS ARE SUPPOSED TO FLOAT

by DALE PEARMAN

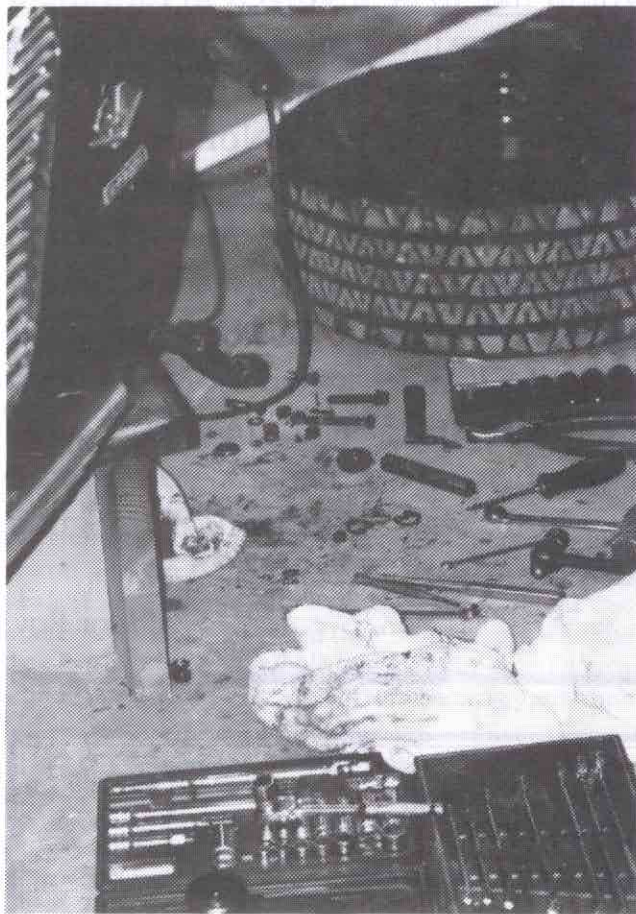
Figure 1

FIGURE 1 shows a scene that is commonplace around my shop. It shows yet another time I am replacing the kingpin and bushing set on my 1962 Corvette. The front suspension is the same (virtually) for all 1953-63 Corvettes, 1949-54 passenger cars, and certain Chevrolet trucks. General Motors designed this suspension for bias ply 6.70 x 15 inch tires mounted on 15 x 5 or 5½ inch steel wheels. These old tires weigh about 22 pounds and the wheels about 20 for 42 pounds total. The tire cross section (tread) measures about 4½ inches. When one yields to the macho urges of a big-fat tire mounted on a "Star-Treck" rim, care must be exercised to avoid increasing the unsprung weight unduly since the added weight will degrade the handling characteristics of any sports car and especially straight axle Corvettes. Some may ask, "How much

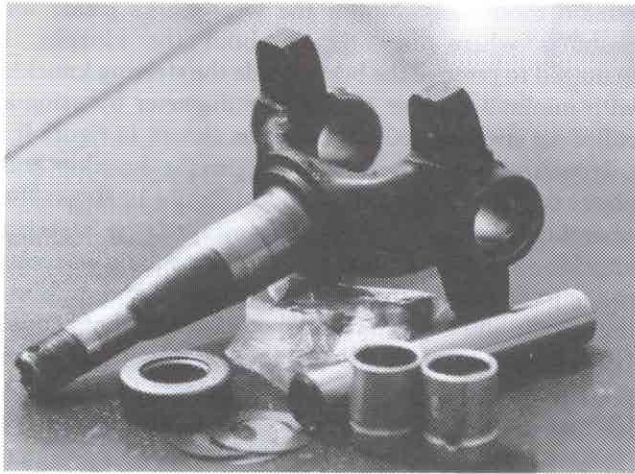
General Motors recommends lubricating 22 grease fittings on your front end every 1000 miles or every Saturday morning, whichever comes first. These old suspensions used kingpins and bushings instead of ball joints. The whole suspension is bushed metal-on-metal. Figure 2 is a photograph of a steering knuckle and spindle with kingpin, bushings, thrust bearing, shims, and inside the bag are welsh plugs, dust caps, retainer bolts, and nuts with lock washers.

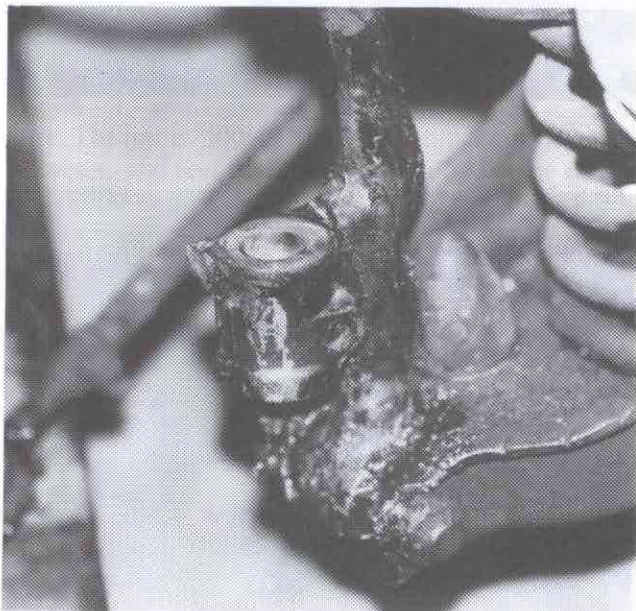
Figure 3 shows the steering knuckle holder. Figure 4 is a G.M. drawing of how it all fits together. My knowledgeable friend, Paul Adams has for years insisted that since my tires are twice as wide, I need to lubricate the front suspension twice as often or every 500 miles. The reason is that the wider footprint sees more pavement surface irregularities and causes the suspension to work twice as hard. I have come to believe Paul, (although with some reservations) after having replaced my kingpin bushings three times in less than 100,000 miles!

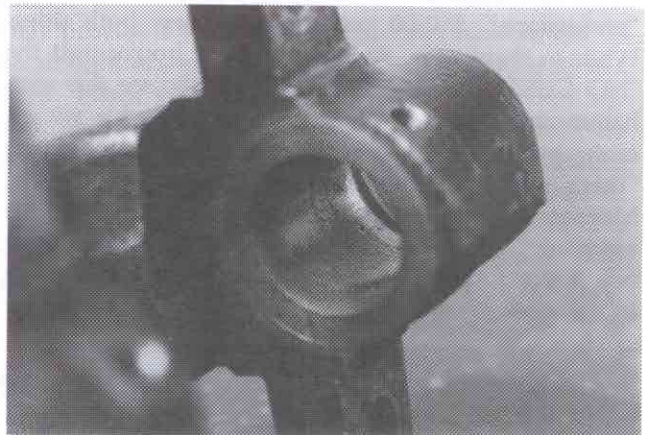
The failure this time is NOT due to lack of grease. It is due to incorrect installation technique. I have learned that the practice is called a "California Shim" and I have seen Corvettes repaired this way on several occasions. Only my passenger side bushings failed. About a year and a half ago I was in the process of building my restoration shop and didn't have time to fool with replacing kingpins and bushings. I instead paid a "professional" \$50.00 per hour to renew both sides. While in the waiting room I looked in horror past the "NO CUSTOMERS ALLOWED" sign to see this man hammering the inside of my steering knuckle with a center punch! "Hey", I yelled lunging for the hammer, "that's where the bushings go!" "take it easy", Mr. Manager said rushing to the bench between me and the mechanic. "Come into my office and I'll explain what he's doing. Insurance regulations don't allow customers in the work area."

Figures 6 and 7 show the "California Shim" damage to the steering knuckle caused by Spike and his center punch.
