MYSTERIOUS NUMBER

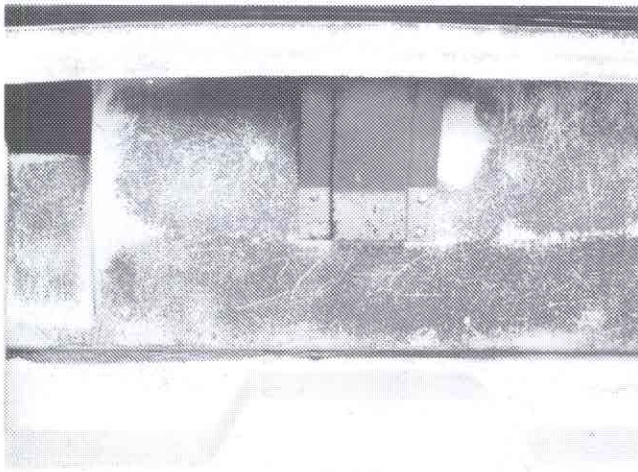
Enclosed is a picture that I took of the filler panel in the trunk on Ken Weichman's 1957. I shot this picture in September 1990 at Ken's house while attending the NCC/NCRS show. Ken was showing me his car when I looked inside the trunk and observed the markings 36-C, as is in the enclosed picture. When I asked Ken about it, he said he had never noticed it before and had no idea what it meant. What do you think? Note that this car has been bead blasted and I don't know if this was visible prior to blasting. I would guess that it was not. I would further guess that it must be some kind of color indicator.
